AVIATION INVESTIGATION REPORT

A00Q0116

RISK OF COLLISION

MONTRÉAL INTERNATIONAL AIRPORT (DORVAL), QUEBEC

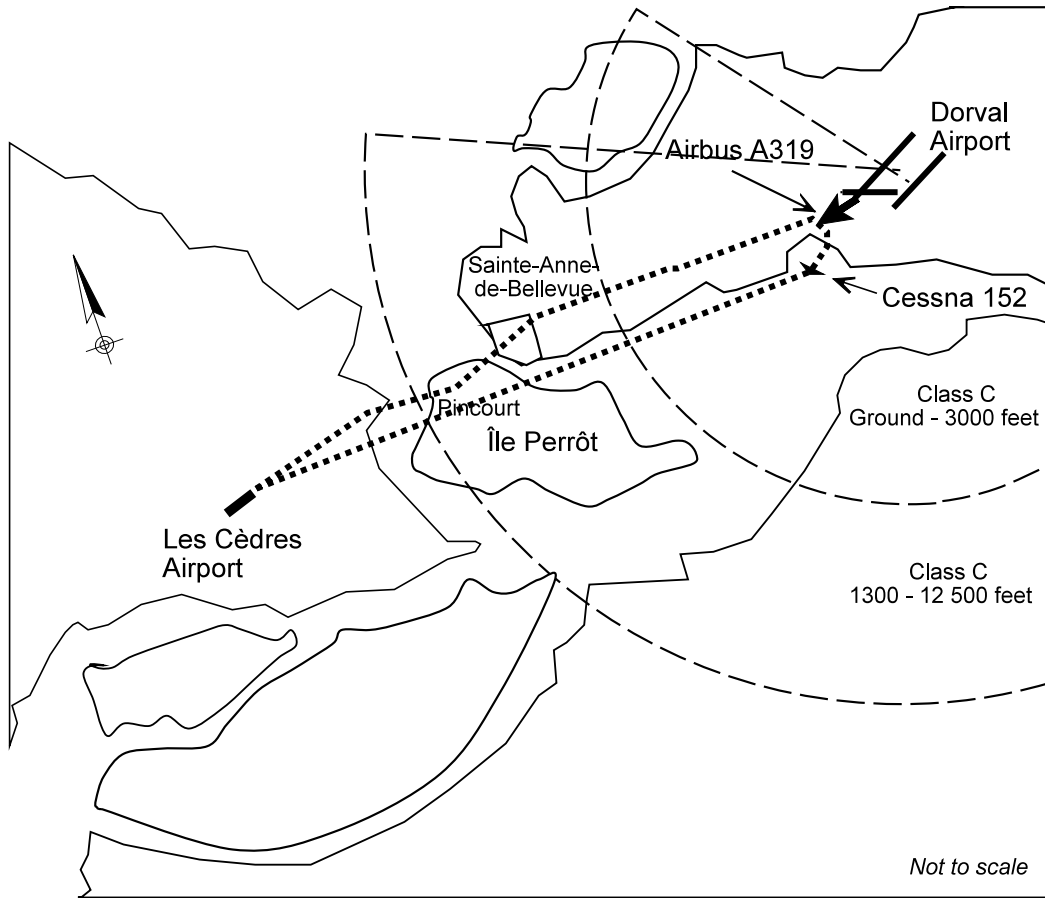
Appendix A—Cessna 152 Route of Flight

The Cessna pilot was aware of the airspace classification in the vicinity of Dorval. After take-off, the pilot established the aircraft altitude at 1100 feet asl to remain below the Class C airspace, which is based at 1300 feet asl and which overlies Île Perrôt and the western tip of the island of Montréal. The pilot planned to follow Highway 20 eastbound only as far as Sainte-Anne-de-Bellevue, 10 nm west southwest of Dorval and outside the Dorval control zone. She thought that the aircraft had not yet passed Pincourt on Île Perrôt when she saw Dorval airport directly ahead. She immediately recognized the navigation error, performed a general lookout, and then began an immediate right turn with the intention of returning to Les Cèdres. During the right turn, the Cessna passed in front of the Airbus. The occupants of the Cessna did not see the Airbus.

1. The pilot of the Cessna inadvertently flew the aircraft within one mile of the Dorval airport, directly into the departure path of the Airbus.
2. The pilot of the Cessna entered the Dorval control zone without receiving air traffic control (ATC) clearance and without activating the aircraft transponder. She thus reduced the chance of being detected by ATC and eliminated the chance of being detected by the traffic alert and collision-avoidance system on the Airbus.
